JAPAN - 2011 Fukushima Nuclear Plant Damage assessment Map

March 16th, 2011
Scale 1:10.000

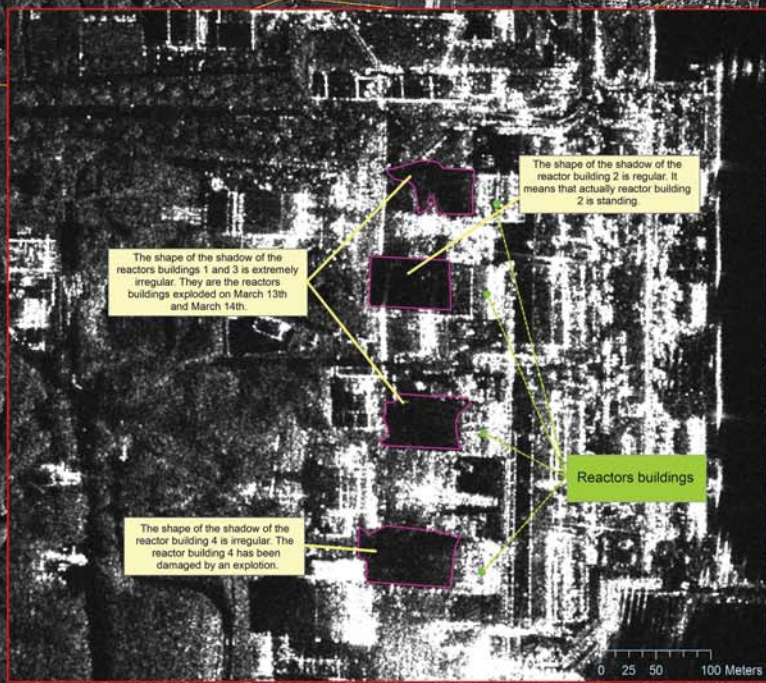
Through the analysis of the COSMO-SkyMed Spotlight image (1 m resolution) acquired on March 16th it is possible to extract information concerning the reactors buildings status. Analysing the reactors building shadow, it is evident that the shape of the reactors building 1-3-4 is clearly modified, due to the subsequent explosions. From the analysis results it is evident that the reactor building 2 is standing.
