The 2011 off the Pacific coast of Tohoku Pacific Earthquake and the seismic damage to the NPPs

4th April, 2011

Nuclear and Industrial Safety Agency (NISA)
Japan Nuclear Energy Safety Organization (JNES)

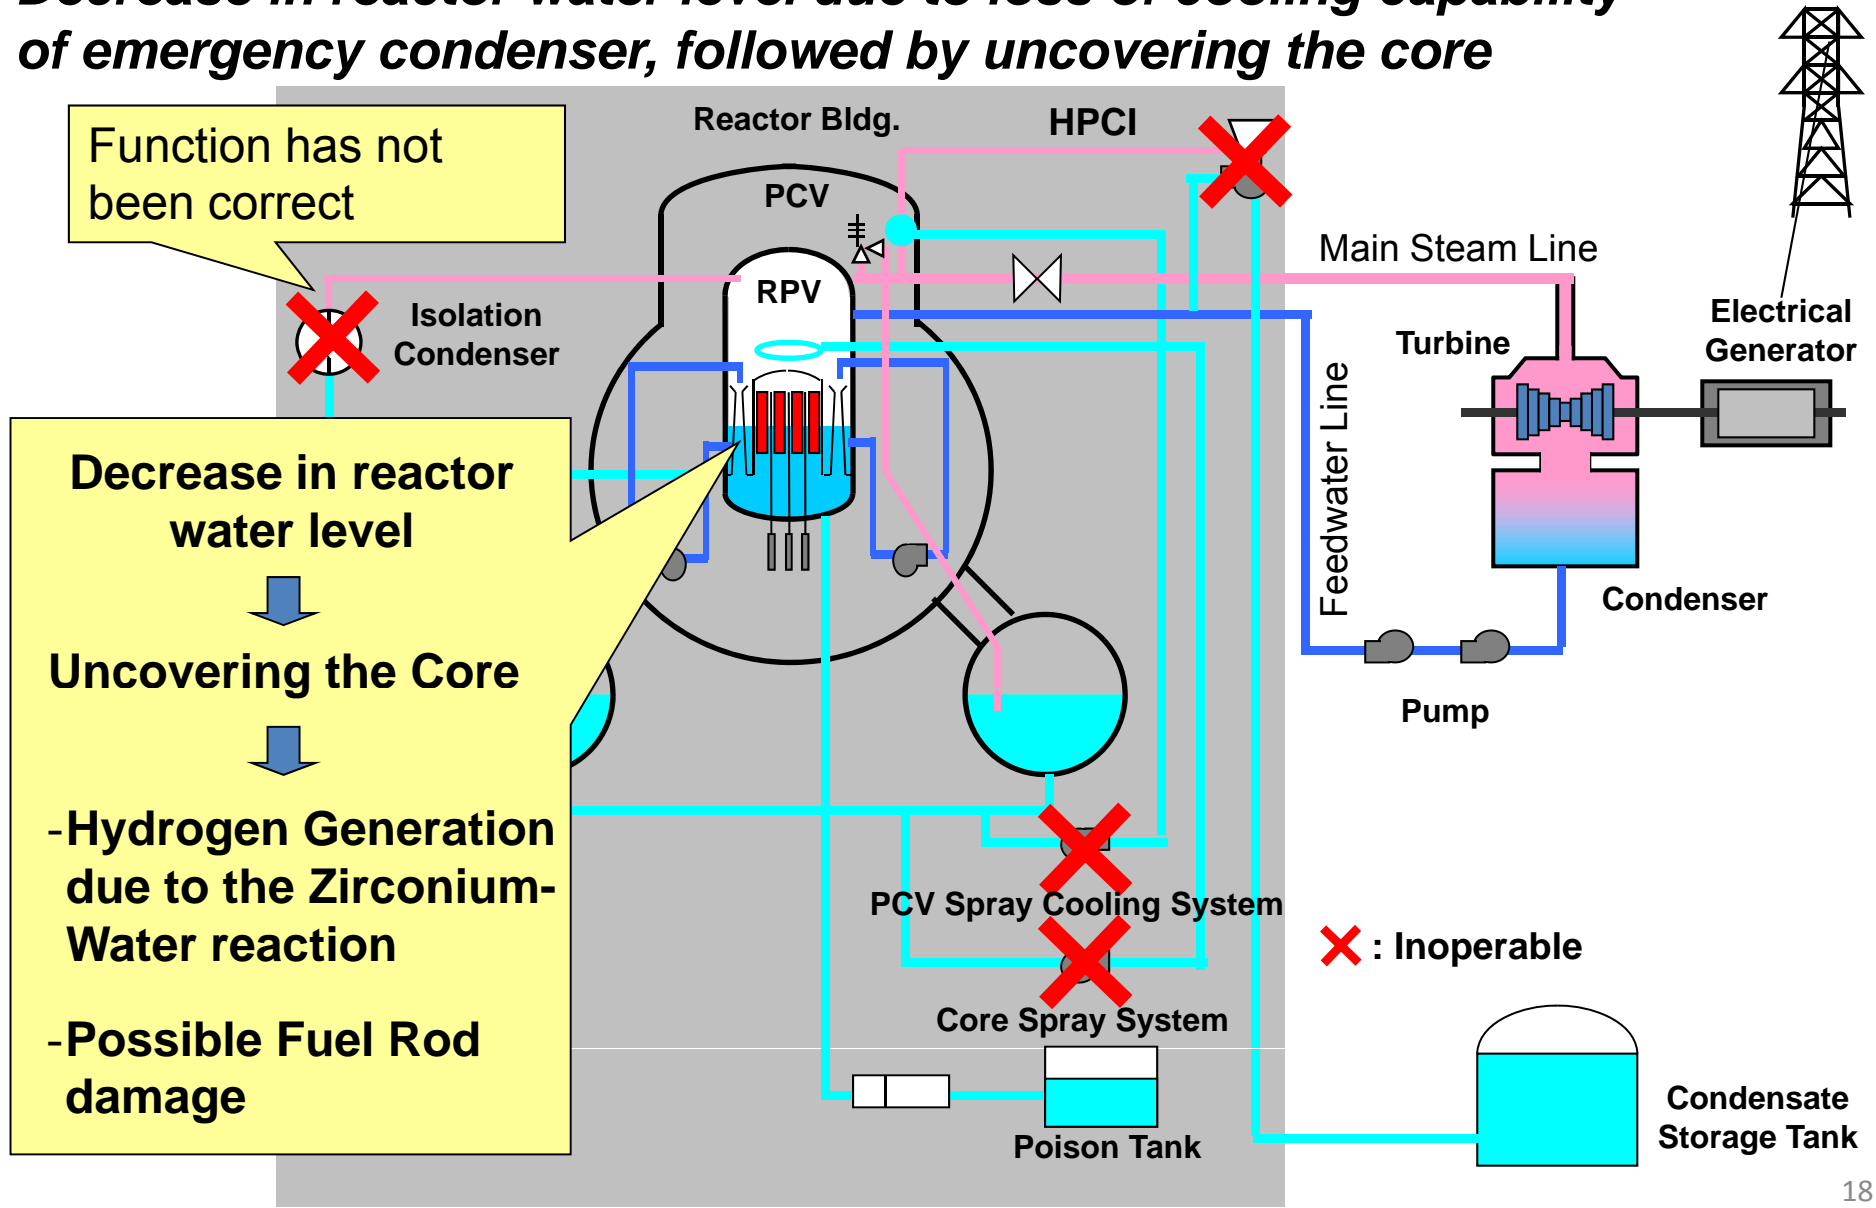
3-7. Major event progression at Unit 1 (2/4)

Decrease in reactor water level due to loss of cooling capability of emergency condenser, followed by uncovering the core

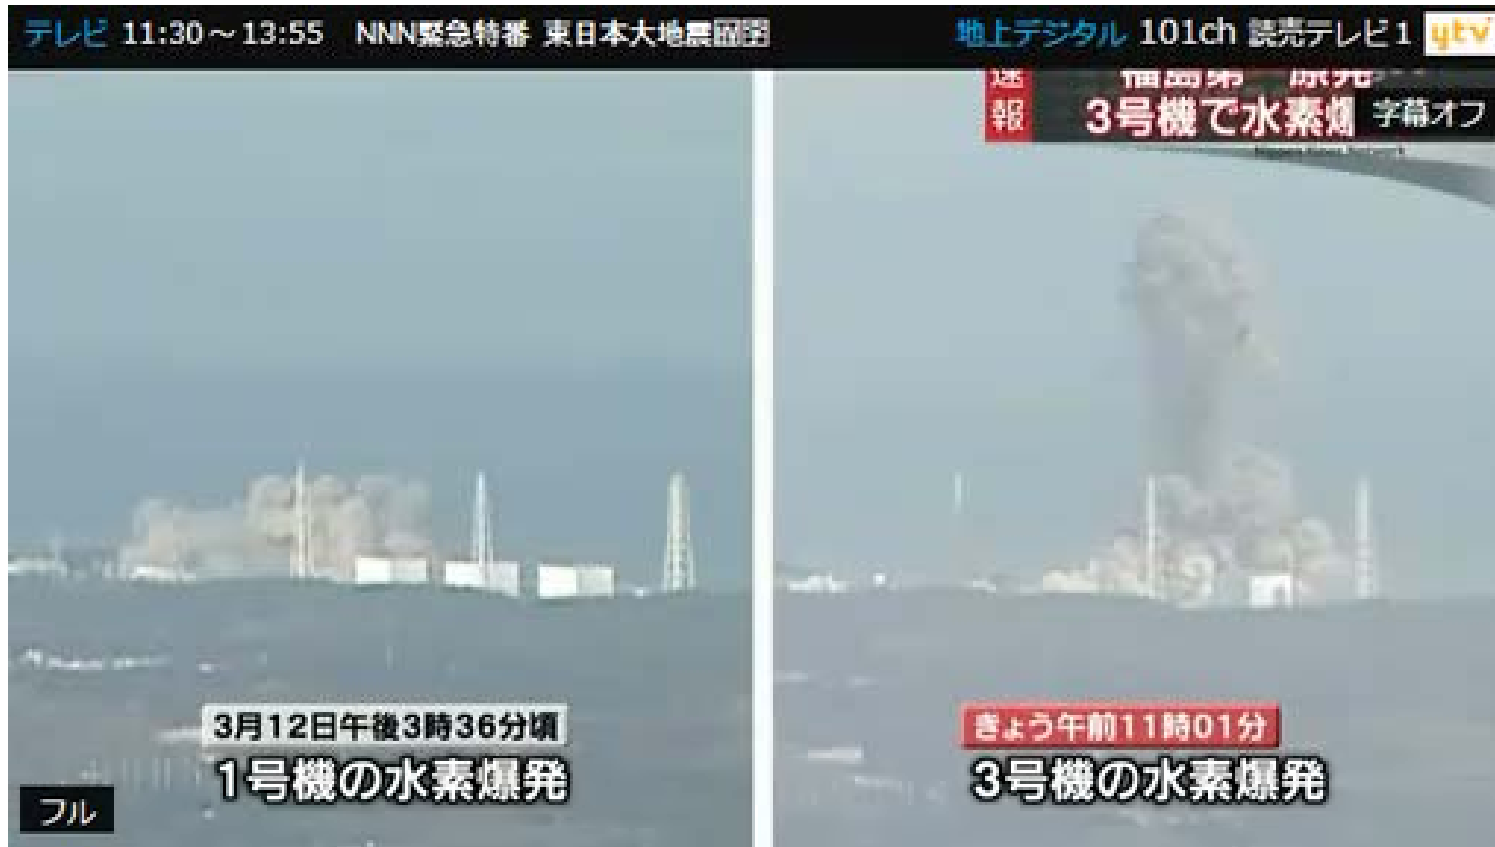
3-15. Hydrogen explosion at Unit 1 & 3

Unit 1

Unit 3

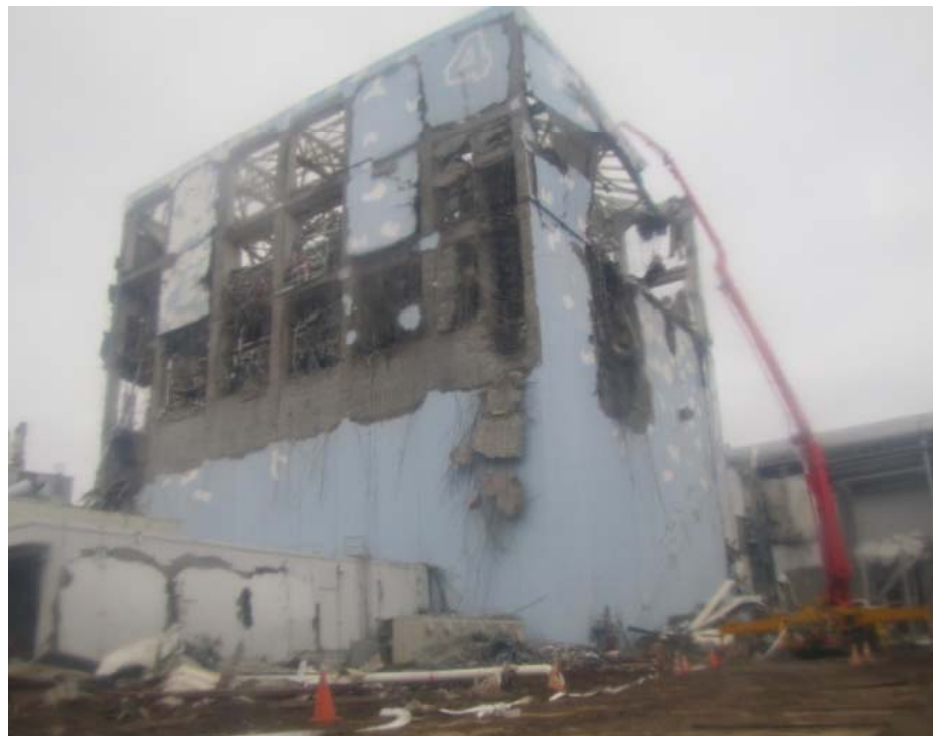
Photo: Water spray into the SFP in Unit 4 using concrete pump truck

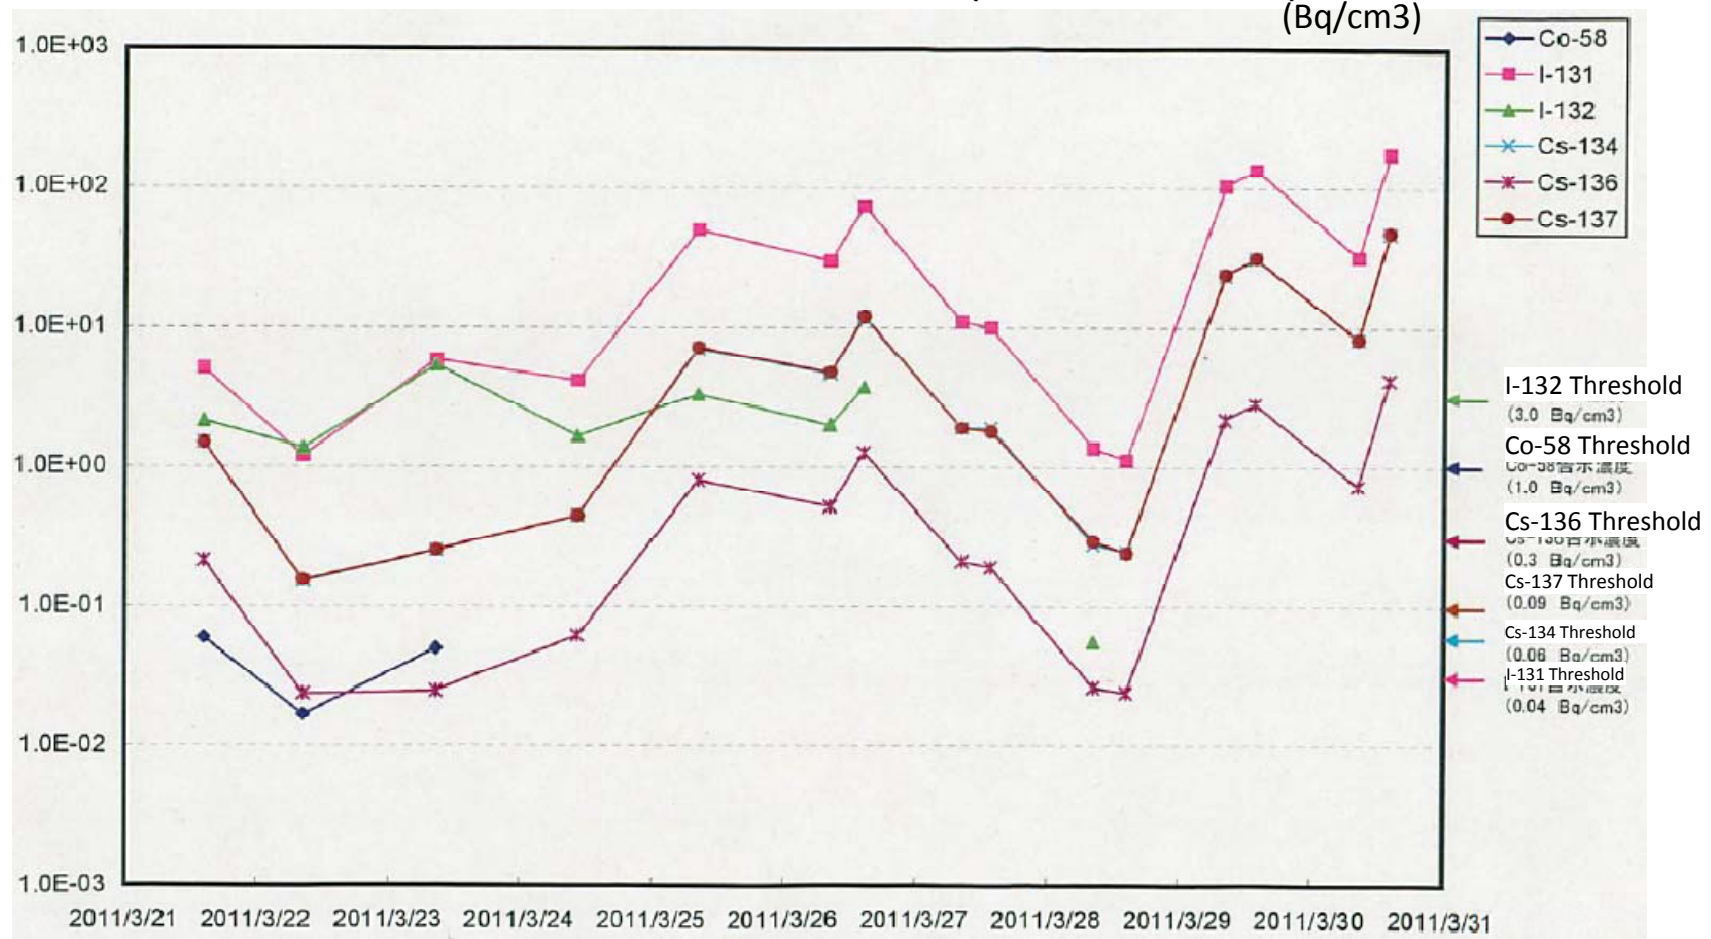
Concentration in Seawater near (1F South Outlet)
(Bq/cm³)

- Concentration of radioactive iodine-131 recorded on March 31st was approx. 4385 times the limit set for water outside the environmental monitoring area.
